The lifting operation above one of Spain's busiest roads turned out to be more complex than anticipated

A STITCH IN TIME

An unusual lifting operation over a freeway used by over a million vehicles per day gave engineers cause to scratch their heads when a deck section refused to shift, reports **José María Sánchez de Muniáin**

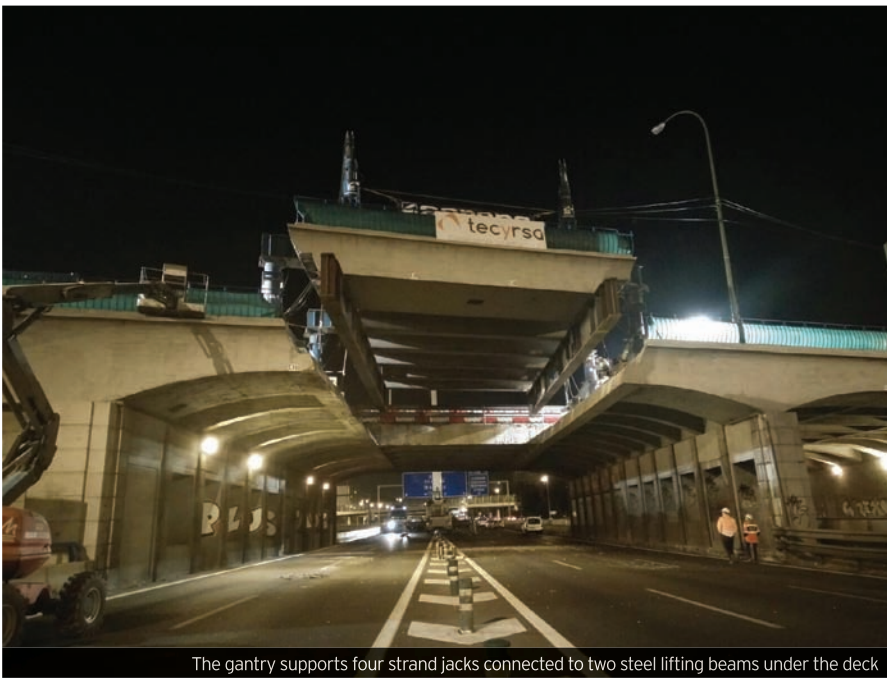
The gantry supports four strand jacks connected to two steel lifting beams under the deck
