A STITCH IN TIME

An unusual lifting operation over a freeway used by over a million vehicles per day gave engineers cause to scratch their heads when a deck section refused to shift, reports **José María Sánchez de Muniáin**

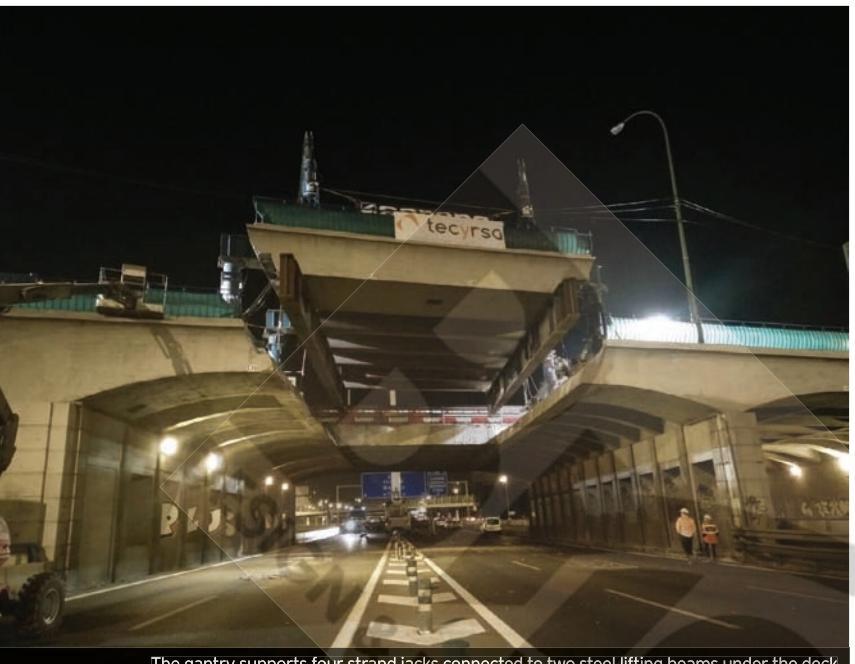
The gantry supports four strand jacks connected to two steel lifting beams under the deck
